DATE: March 17, 2011
TO: Distributors, Dealers, and Installers of Xantrex
North American and Korean Single Phase GT Series Grid Tie Inverters
SUBJECT: North American and Korean Single Phase GT Series Grid Tie Inverter Recall – Change To Field Repair Kit

DEALER / INSTALLER UPDATE

Appendix 1

Product Identification

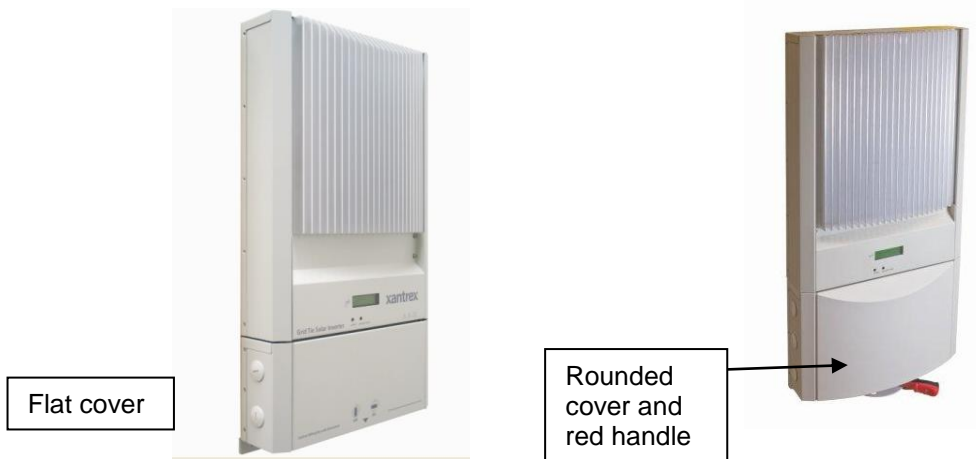
Original wiring compartment

Flat cover

All affected models with 7- or 8-digit part numbers.

Order bracket kit 864-9004

New compartment with Square-D disconnect

Rounded cover and red handle

5 affected models with part numbers ending in -02

Order bracket kit 864-9005
